Mandibular Fracture in A Patient Treated with A Protocol Prosthesis after 3 Years of Function due to Biomechanical Complications - Clinical Case Report

The article presents a case of mandible fracture caused by the loss of an implantina protocol prosthesis increasing cantilever, causing bone loss around the implant. The fracture was treated by rigid fixation, four implants and a new prosthesis. The authors discuss the possible causes and prevention of this complication.

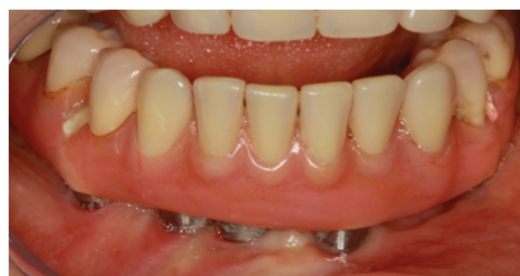
During the visit, an increase in volume was observed in the posterior region of the mandible on the right side and mobility in the region of the most distal implant, where it was impossible to diagnose whether the mobility was from the implant or resulting from the mandibular fracture (Figure 1). After the images were examined, a radiolucent line was observed beginning at the crest of the flap and continuing to the basal at the implant, characterizing a mandibular fracture without detachment of fragments. It was also possible to observe that this was a mandible with

Figure 1: Clinical situation of the patient at the first visit, where the lack of implants can be observed in the posterior region of the mandible on the left side.

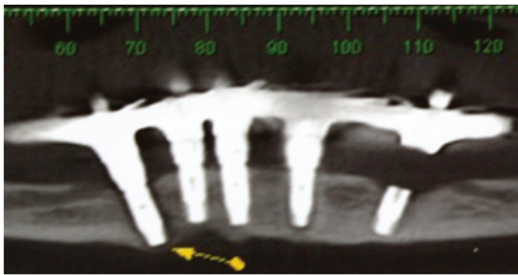
little bone height and the other implants revealed marginal bone loss with the exception of one (Figures 2 and 3).

Figure 2: Tomographic cuts where the fractured implant can be observed on the left side of the mandible and the radiolucent peri-implant of the distal implant on the right side, suggesting mandibular fracture.

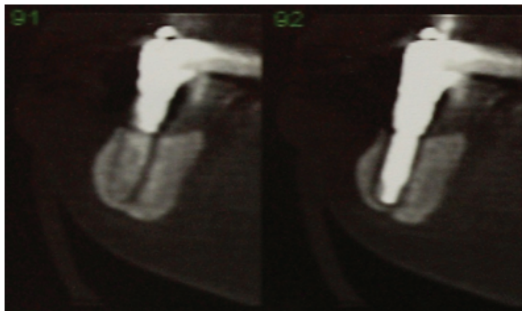
Figure 3: Tomographic cuts of the distal implant where the mandibular fracture can be confirmed without detachment.

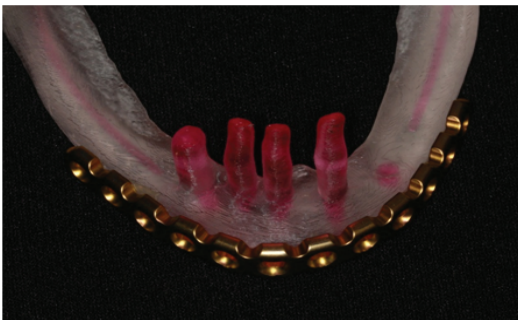
Figure 4: Prototype with the individualized reconstruction plate and the four remaining implants. The linear arrangement of implants compromising rehabilitation biomechanics can be observed.

After the loss of the distal implant on the left side, prosthetic rehabilitation was anchored in 4 implants. Despite the positive results presented in literature in inferior protocols with four implants [2,3,12,13], the arrangement of the remaining implants resulted in a very big distal cantilever on the left side, since the last implant was in the region of the lower, lateral incisor and the polygon formed by the arrangement of the implants was also very unfavorable since they were in a linear position. Literature states the success of the protocols with 4 implants is directly tied to the positioning of the implants and the size of the cantilever [3,13,14].

The patient underwent general anesthesia and through an extra-oral access, the mandibular fracture was reduced and affixed with a straight plate and 2.4 mm fixation screws (Synthes-Oberdorf/Switzerland), previously individualized in a prototype model (Figures 4 and 5).

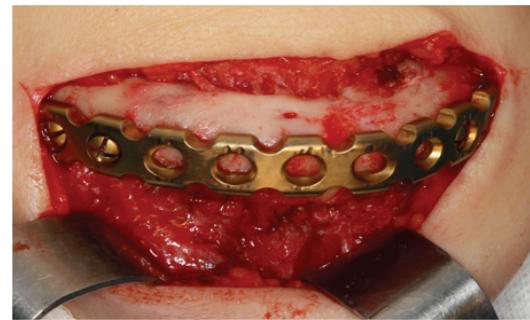
Figure 5: Surgical aspect of the extra-oral access, with the installed plate. In the region anterior to the mandible, screws were not placed to permit installation of the implants.

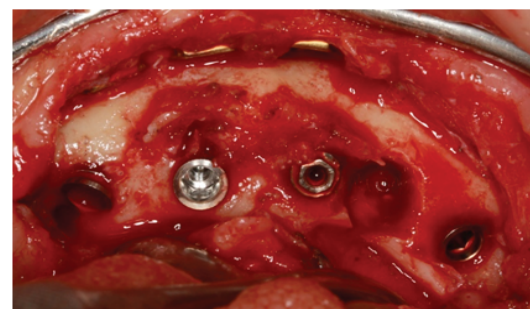
Figure 6: Implants installed and maintenance of one of the already existing ones.

Using an intra-buccal incision, the implants were removed with the exception of the central implant which was in good clinical conditions. The fragment of the fractured implant was also removed. Three more 4.3 x 10 mm internal hexagon and Vulcano surface implants (Prosthesis Connection System – Arujá/SP-Brazil) were installed, in which the two distal implants had an inclination of about 45° as per the al-on 4 technique (Figure 6). The implant installed near the fracture region had little primary stability and for that reason it was decided to not use immediate load treatment.

Although there are fewer implants than in the original treatment, the distal implants were installed at an inclination, reducing the distal cantilever for both sides and increasing the resulting polygon between implants.

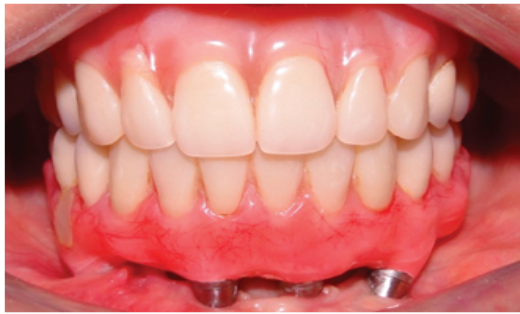
Figure 7: Clinical aspect showing the arrangement of the implants, reducing the cantilevers and the normal aspect of peri-implant soft tissue.

Clinical controls were conducted after 15 days, when a new occlusal adjustment and check of screw torque was made. After 3, 6 and 9 months, clinical controls were conducted and after 12 months a clinical and radiograph control. In all these controls and images, clinical normalcy was observed (Figures 7 and 8).

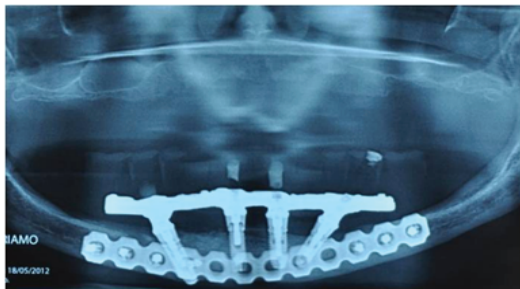
Figure 8: Control radiograph at 12 months where a situation of normalcy can be observed in fracture treatment and around the implants.
