Application of UAV for Sewer Pipe Inspection

NJS Co., Ltd., Minato-ku, Tokyo, Japan

Abstract

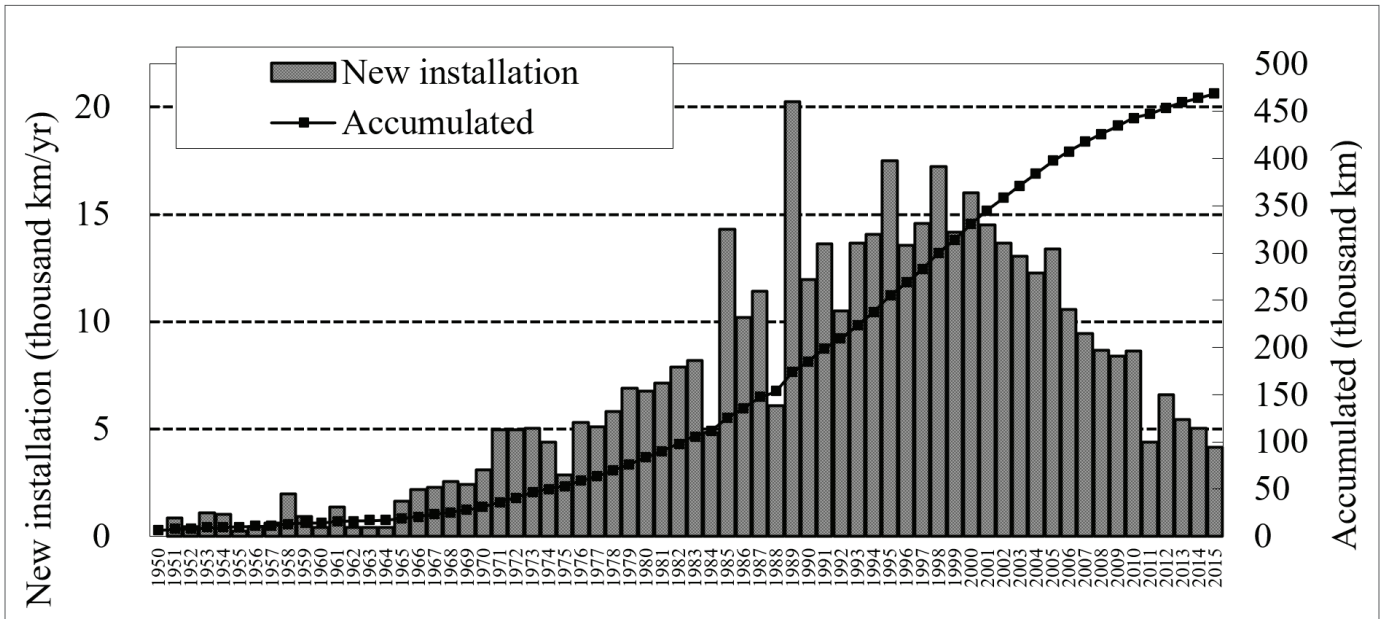
Figure 1: New sewer construction and accumulated length by year in Japan.
Made by author, based on the statistics of Japan Sewage Works Association [3].

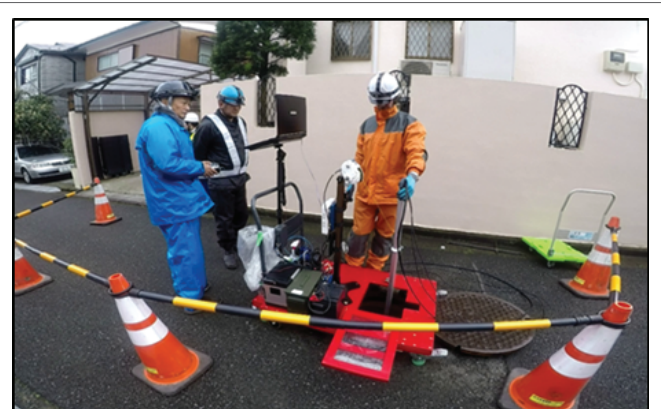
Figure 5: Operators working from above ground in UAV inspection.

process from above ground, including preparation, inspection and clean up (Figures 4 and 5).
